Sassafras Update

Sassafras River Association
P.O. Box 333
Georgetown, MD 21930
www.sassafrasriver.org

December 2010

Specialized Wetland to Treat Nutrients and Sediments

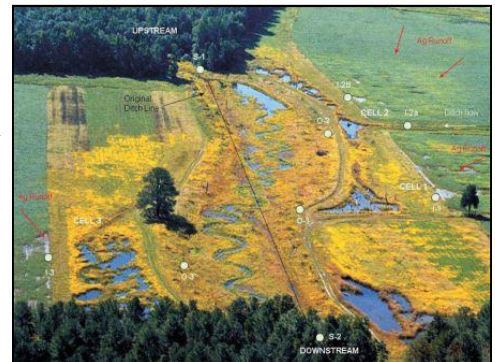
Model Constructed Wetland project in Kent County, DE

Lead project engineer, Albert McCullough, of Sustainable Science in Denton, MD, steered the direction of the group toward a fairly new and innovative technique called "vertical flow treatment wetlands", which is a series of wetland cells that are sized and designed to remove nitrogen and phosphorus from the water as it percolates and moves through the soils and plant communities. Originally designed

for treating wastewater in more urban settings and to treat dairy and swine waste effluent, this project will be the first time that this tool will be utilized in a non-point source, rural application. Because of the high storm loads, Mr. McCullough is working closely with NRCS engineer Anne Baldwin to design a forebay to retain water during high precipitation events. The forebay will be outfitted with a custom designed floating outlet orifice to ensure a constant but consistent flow into the wetland system which is vital to optimal function and nutrient removal. As part of the project, SRA intends to work hand in hand with Cecil County NRCS to restore the degraded natural wetland and stream. Not only will this create vital wetland
